# **REMEDIAL ACTION REPORT**

**AOC-24: Woodbridge Pond**

**HATCO CORPORATION SITE**

**November 2020**

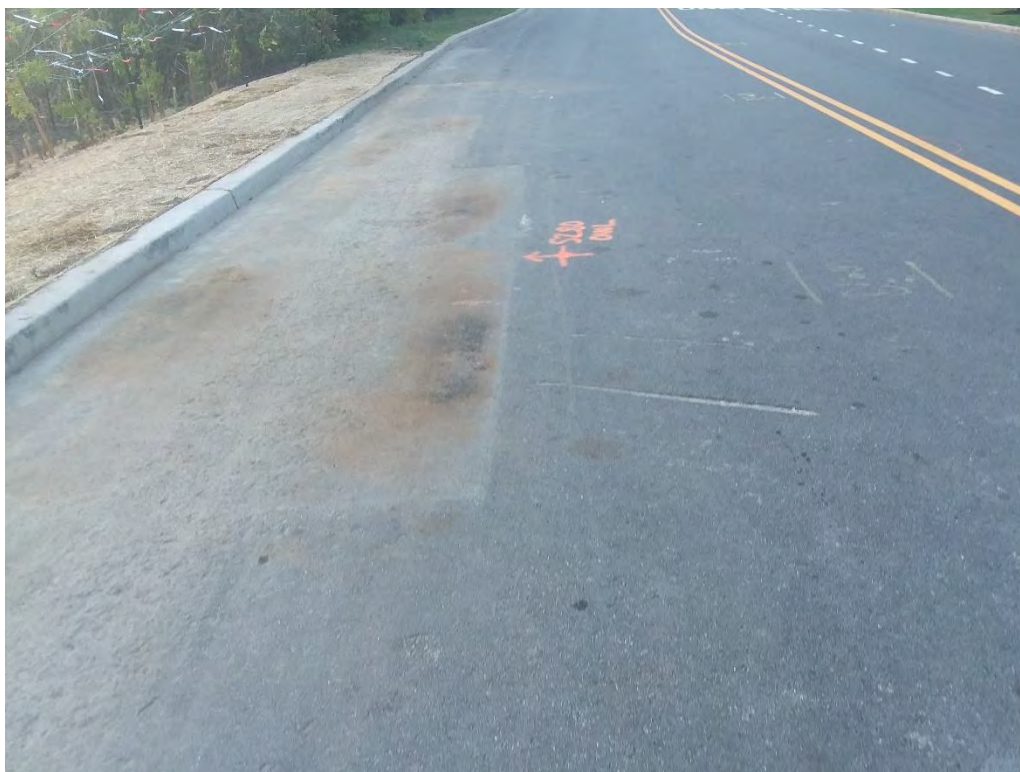
September 19, 2019. Final inspection of Mac Lane area restoration and curb line

On September 18 and 19, 2019, grass seed was spread to restore the shoulder area along Mac Lane. The concrete curb was inspected and minor cracks were repaired as requested by the Woodbridge Township Engineer. All equipment and materials were removed from the site and field office as of September 23, 2019. Weston and SES completed a final walkthrough inspection with the Woodbridge Township Engineer on September 27, 2019.

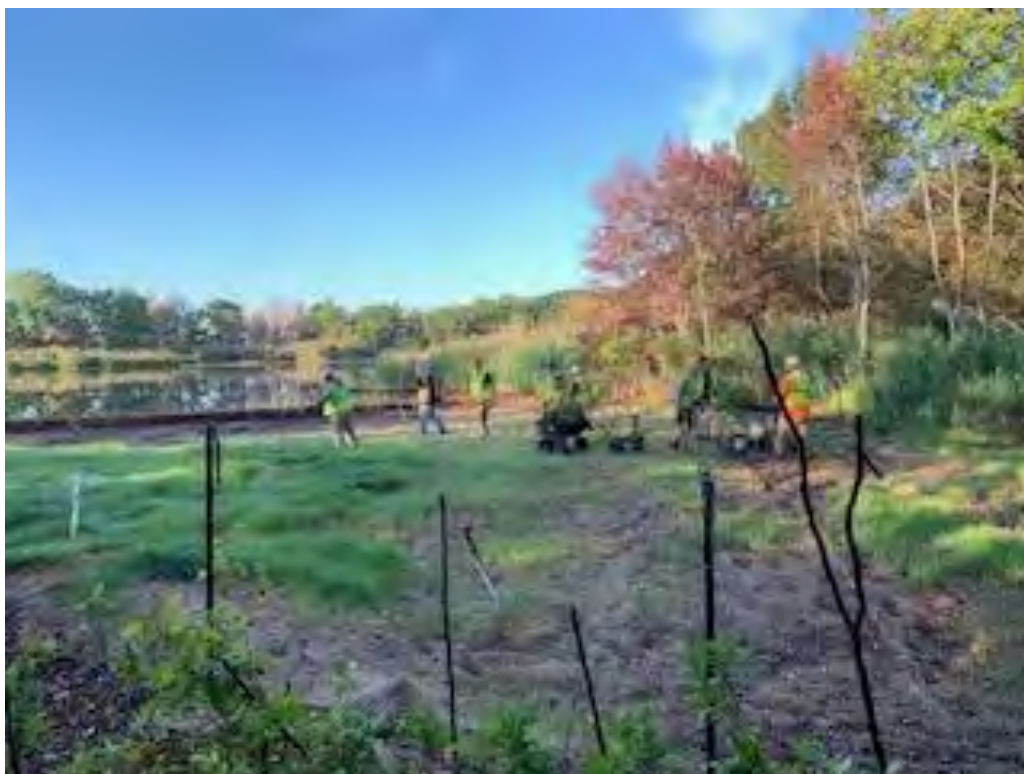
September 21, 2019. Installation of plantings in northern wetland restoration area
